ITT Goulds Pumps XHD Solutions: Mill Discharge Application XHD delivers reliable performance and reduced Total Cost of Ownership at a Silver Mine in Mexico

Goulds XHD solution for a difficult mill discharge application

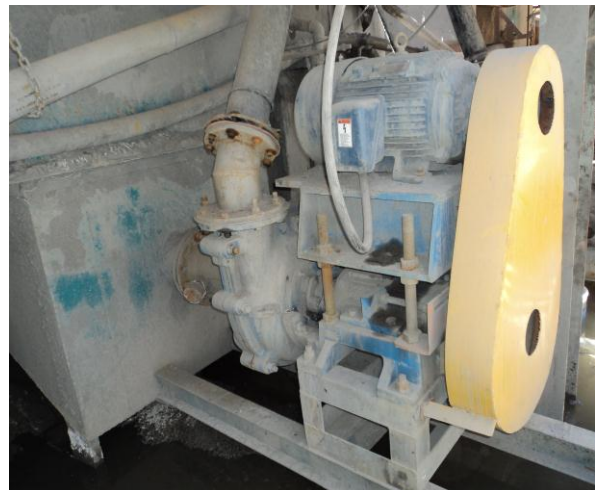
Goulds 125 XHD pump installed on oxides/sulfides slurry mill discharge at a silver mine in Northern Mexico. The customer built the adaptor base under the pump in order to align the pump flange with the suction piping.

ITT Goulds Pumps reviewed the application details and proposed the new 125 XHD pump with HC600 liners and impeller. The compact pedestal made it easier to install the pump in the current location with the use of an adaptor base to line up the pump suction flange with the piping. The customer opted to make the adaptor base in house.

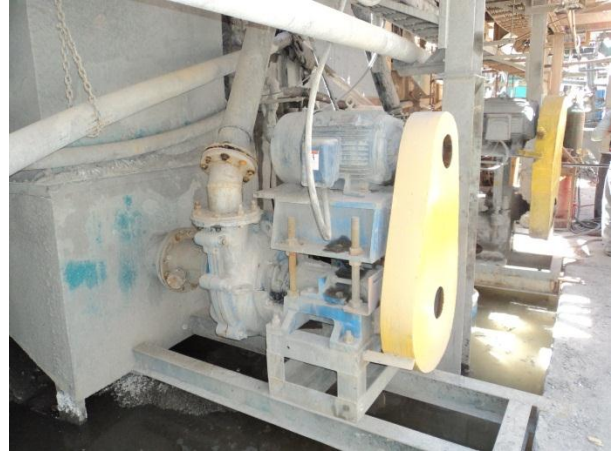
The Goulds 125 XHD pump on mill discharge duty. The competitor's 8x6-18 pump can be seen in the background.
